**CONDITION ASSESSMENT OF MEDIUM-POWER TRANSFORMERS
USING DIAGNOSTIC METHODS: PDC, FDS, FRA TO SUPPORT DECISION
TO MODERNIZE OR REPLACE SERVICE-AGED UNITS**

R. MALEWSKI* J. SUBOCZ M. SZROT, J. PŁOWUCHA, R. ZALESKI
Instytut Elektrotechniki Politechnika Szczecińska Energo-Complex
Poland

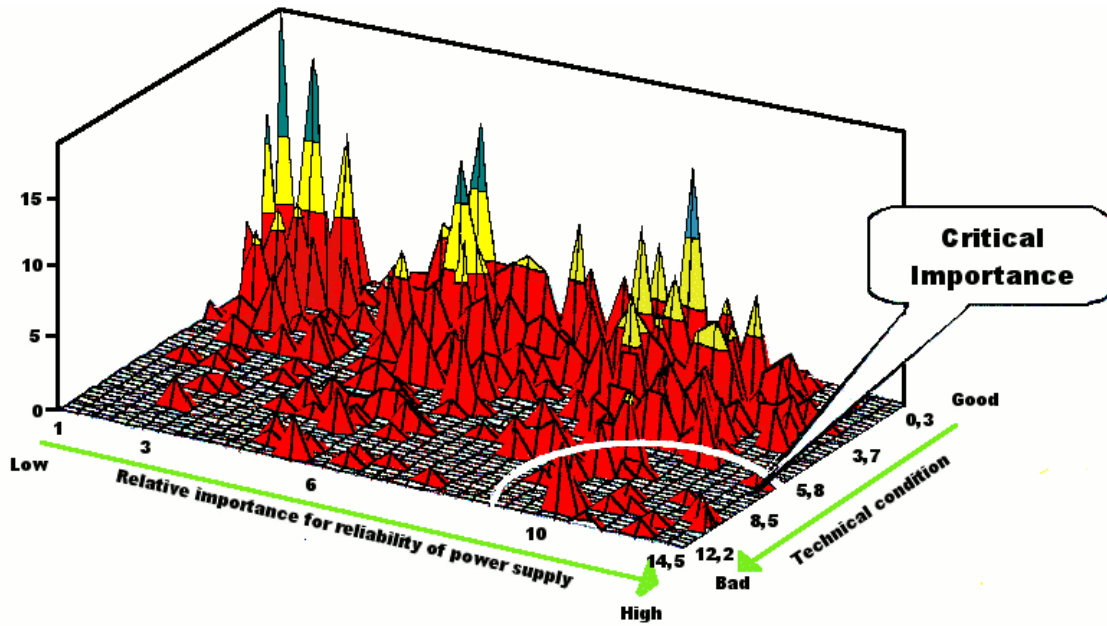
Fig. 3. (After [2, 3]). An example of 900 transformers with their relative importance for system reliability plotted against the transformer technical condition. Such graph forms the base of a ranking list of transformers to be modernized or replaced.

A rational planning of investments requires a ranking list of transformers to be modernized or replaced. Relative importance of each transformer for system reliability, and the transformer technical condition is shown in Fig.3 [2, 3]. Besides, operational costs have to be considered, although some utilities prefer to keep older transformers in service despite their high loss and costly maintenance, just to postpone investment in modernization or replacement.

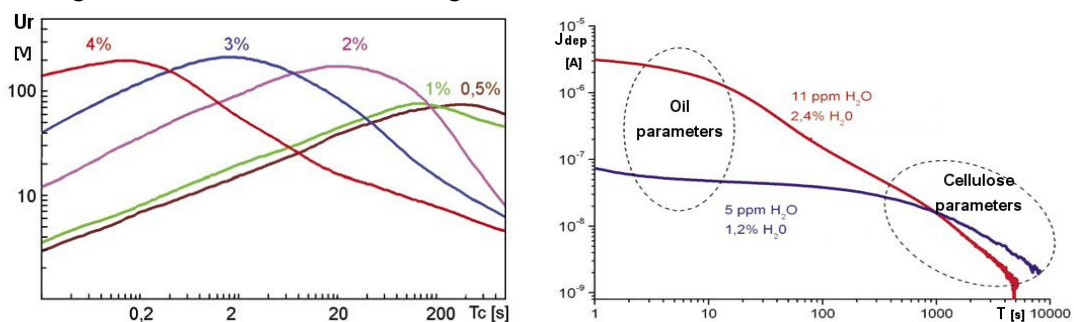
Fig. 4. Water content in cellulose [%] revealed by the Recovery Voltage curves for five different insulation samples – left graph. Water content in oil [ppm] and in cellulose [%] derived from Depolarization Current characteristic measured on insulation of two transformers – right graph.

Following this research project, our service company Energo-Complex., in collaboration with Szczecin Technical University, has implemented RVM, PDC and FDS techniques to condition assessment of a large number of medium-power transformers. In practice, the owner of a medium-power transformer has to decide on insulation drying, or continued operation. For this purpose it is sufficient to state that water content in cellulose is less than 1%, 2% or 3%, since a more accurate value does not change the transformer owner decision. However, such condition assessment has to be confirmed by more than one diagnostic technique. A typical record of moisture in solid insulation obtained using RVM and PDC is shown in Fig. 4.

excessive water content was indicated in new, factory-dried transformers. With special signal-processing software that corrects the effect of insulation temperature, and reduces influence of oil resistivity, the RVM readings provide useful assessment of moisture content in solid insulation. However, an uncertainty of $\pm 0.5\%$ is not uncommon.

Polarization and depolarization current is recorded for couple of hours after application or short-circuiting a direct voltage. Certain sections of this current decay characteristic reveal water content in oil and in cellulose. The characteristic is analyzed by decomposition into a straight line that reflects oil resistivity, and a few exponential components with different decay time-constants. These time-constants, derived from for instance depolarization current plot, correspond to certain water content in cellulose. Again, this analysis requires reference values obtained by examination of cellulose samples with controlled and known water content. Once calibrated, the depolarization current plot provides water content in oil and in cellulose with accuracy sufficient for transformer condition assessment.

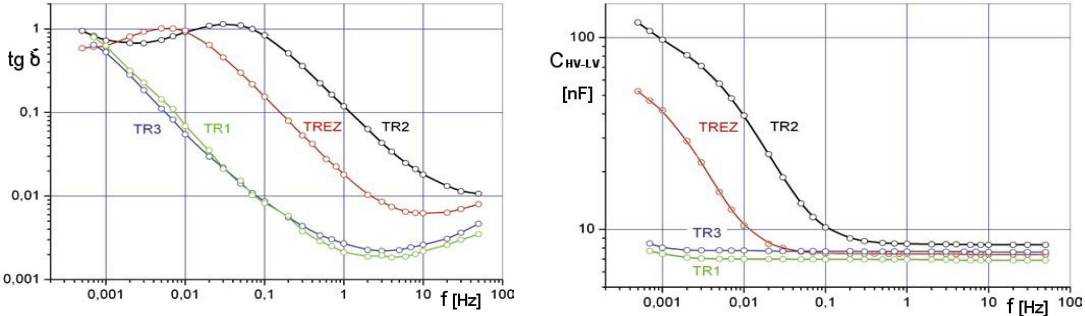
Fig. 5. Dielectric loss factor $\text{tg } \delta$ of main insulation of four GSU transformer plotted as a function of frequency from 0.6 mHz to 60 Hz (left graph). Capacitance of main insulation of the same transformers plotted in the same frequency range (right graph).

Frequency Domain Spectroscopy of paper-oil insulation yields the dielectric loss factor $\text{tg } \delta$ and capacitance frequency-characteristic in very low frequency range. To determine water content in solid insulation these characteristics are analyzed using X-Y model of barrier insulation between the high and low voltage winding [8]. Reference characteristics derived from controlled moisture-content cellulose-samples are required to calibrate the model. Water content in the main insulation of three GSU transformers rated at 75 MVA, 115/10.5 kV is as follows: TR1 – 1.2%, TR2 – 3.2%, TR3 – 1.4% and the reserve unit T_{REZ} – 3.1%. A quick, visual inspection of characteristics shown in Fig. 5 reveals a marked difference between the dry insulation of TR1 and TR3, as compared to rather wet cellulose insulation of TR2 and T_{REZ} .

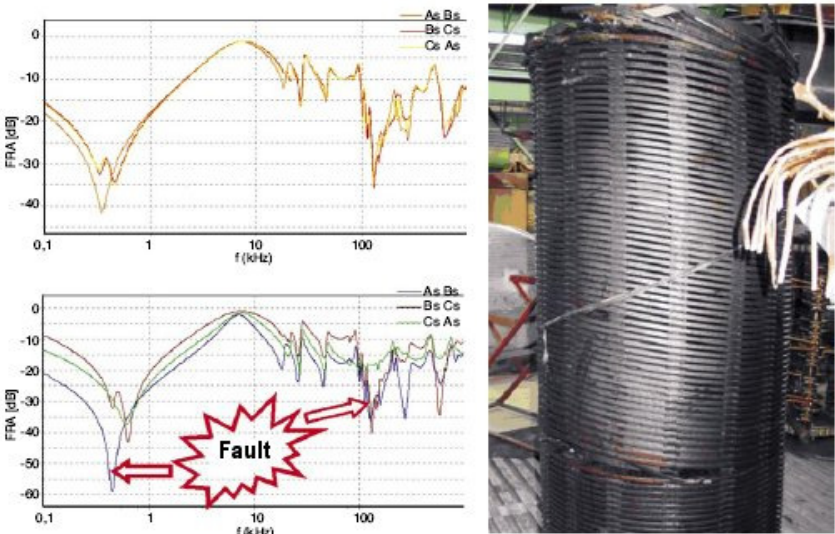
Fig. 6. Frequency response of HV winding of 25 MVA, 115/6.6 kV transformer recorded before (upper graph) and after deformation of this winding by heavy short-circuit current (lower graph).

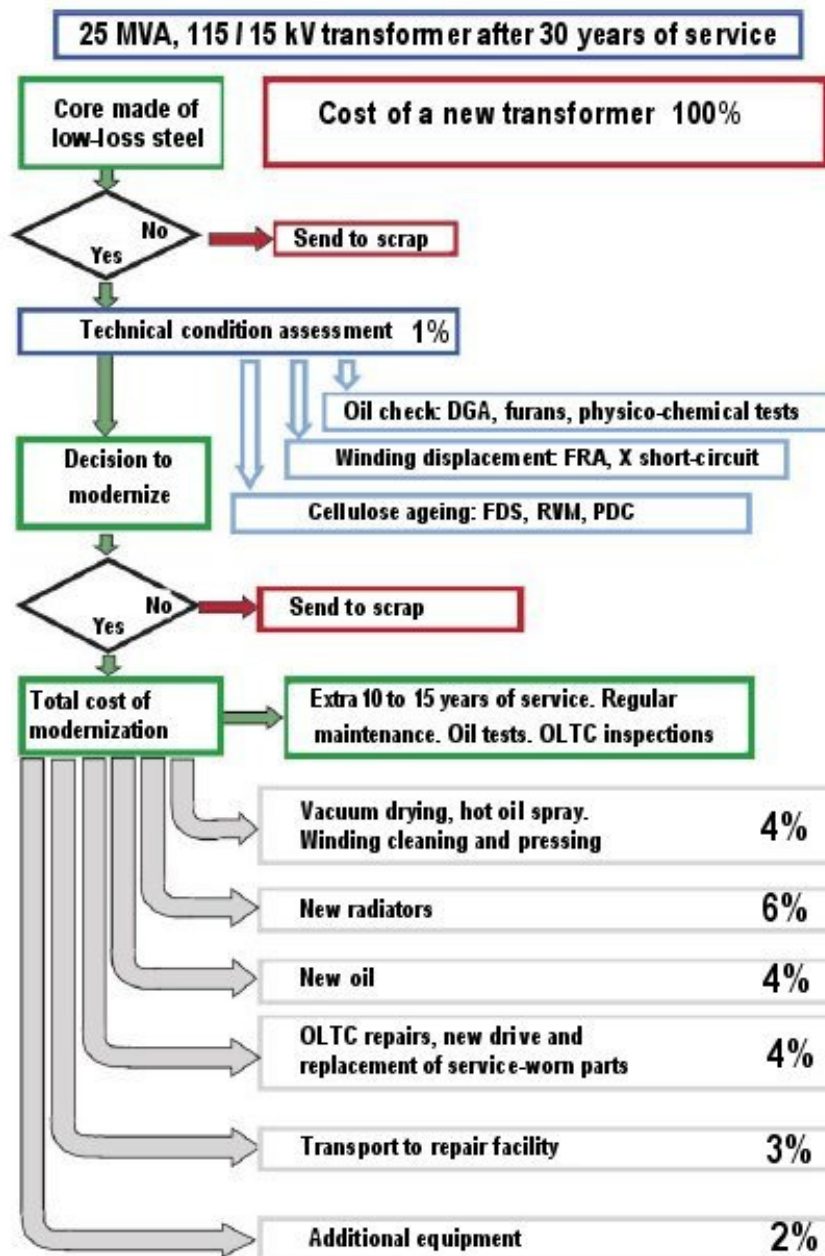
Fig. 7. Core loss evaluation, assessment of winding integrity and cellulose ageing are required to take a decision on sending an older transformer to a repair facility or to scrap. Cost of components and labor involved in modernization of a typical medium-power transformer at a repair facility amounts to 24% of the new transformer cost, including the cost of condition assessment.

Modernization of an older transformer is economically justified if the cost of drying, cleaning and pressing of the windings, replacement of radiators, filling transformer with new oil, overhaul of OLTC, and transport to the repair facility represents an acceptable fraction of the new transformer cost. The modernized unit may serve for another 10 to 15 years, and the investment in the new transformer is postponed. With the sharply increased price of transformer steel and copper, cost of a new unit represents a substantially larger expenditure than modernization that preserves at least the core, windings and tank. The cost of condition assessment is negligible in comparison to the cost of modernization, which is presented in Fig. 7 for a typical transformer rated at 25 MVA, 115/15 kV.
